**THE NEW ARCHAEOLOGICAL RESEARCH AT RUGINOASA-DEALU
DRĂGHICI. PART I, ARCHITECTURE**

CORNELIA-MAGDA LAZAROVICI

GHEORGHE LAZAROVICI

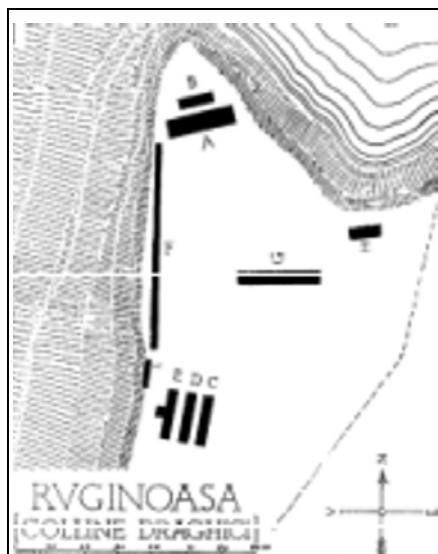
Fig. 1. H. Dumitrescu's plan of the excavations.

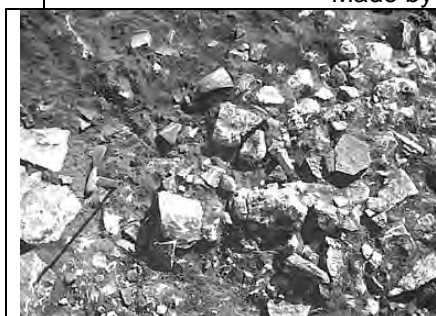
Fig. 8a. The defensive ditch in S1
and house 1 (L1).

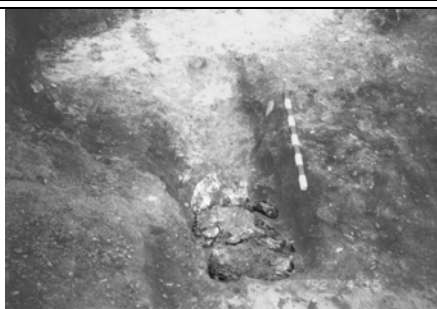
Fig. 9a. Stone pavement in the first fase of the defensive ditch.

Fig. 9b. Stone pavement in the first fase of the defensive ditch.

The first phase of the ditch (Ditch I). The ditch was paved with big slabs of stone, horizontally arranged. This pavement was observed under B1 level and westwards from it, in the destroyed area, up to the base of the ditch. Based on the data we have, the "pavement" was used up to – 2,50 m (the base of the ditch). In the area the excavator destroyed that we have researched the upper part of the defensive ditch. The ditch is edgewise in the profile of the Stone quarry and pit house 1 (B1) was situated on the southern part of the defensive ditch. The stone slabs used for paving the ditch are of local origin. The paving process was intentional, which suggest that the Cucutenians knew very well the local stratigraphy. Beaten yellow clay was placed between stones in order to reinforce the structure (stones and small broken stones have been also discovered as a result of this operation). We do not know exactly the source of this yellow

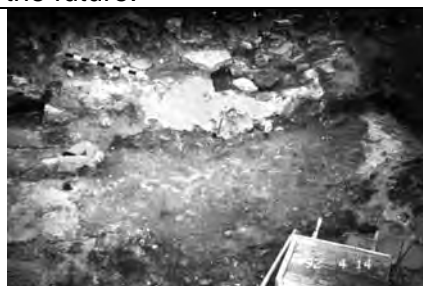
Fig. 10a. The ditch 1 and 2.

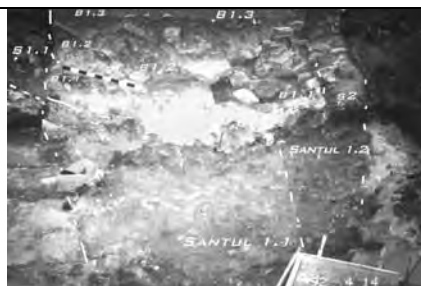
Fig. 10b. Pit house 1 with phases B1.1, B1.2, B1.3 and the ditches, from S1▲.

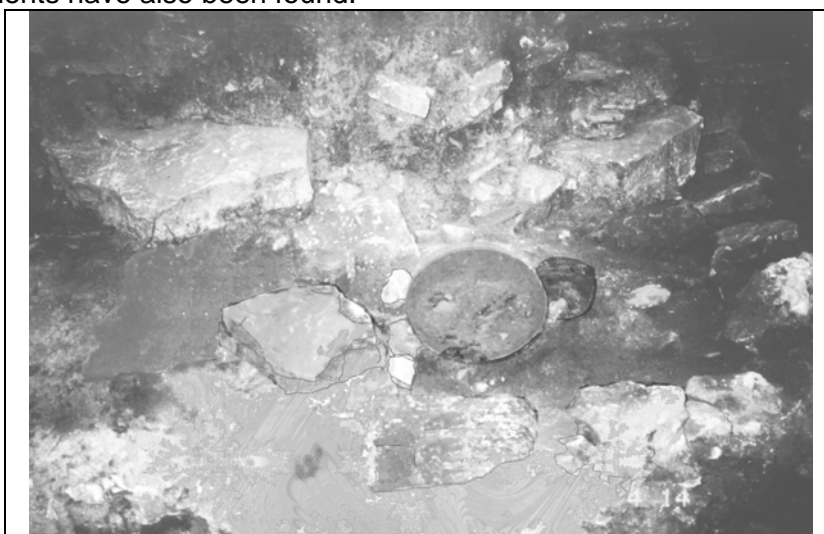
Fig. 13. Pit house 1.1 (B 1.1) and the cup; over it stones from the floor of phase 1.2.

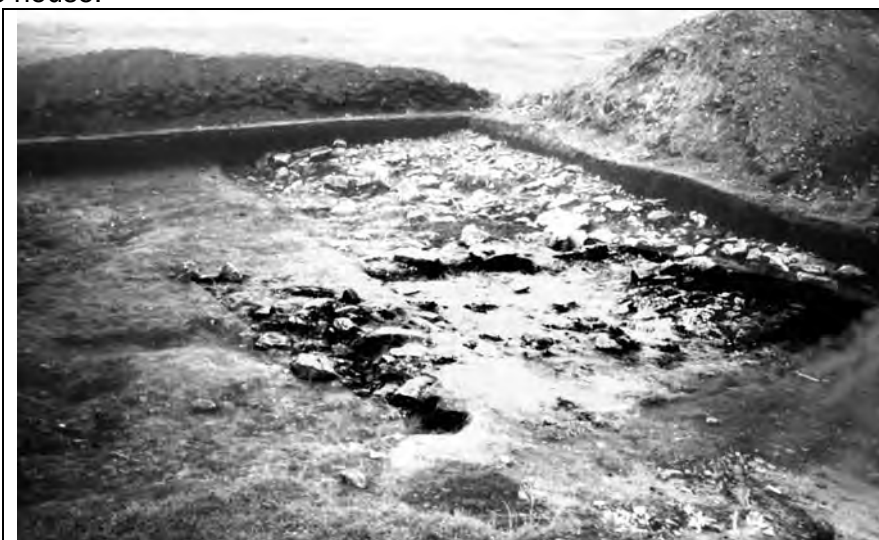
Fig. 15. House 3(L 3), level 3.1 left and 3.2 right.
General view from W, NW.

In the opposite part of the image in fig. 15 it is possible to observe the geological structure and the very thin cultural level outside the ditch. The stone base of a wooden wall is located in the center. In the North part of the house we have found a posthole (fig. 16a, 17a) connected with the north -western corner and a fireplace (situated on the North part of the interior wall, fig. 16b).

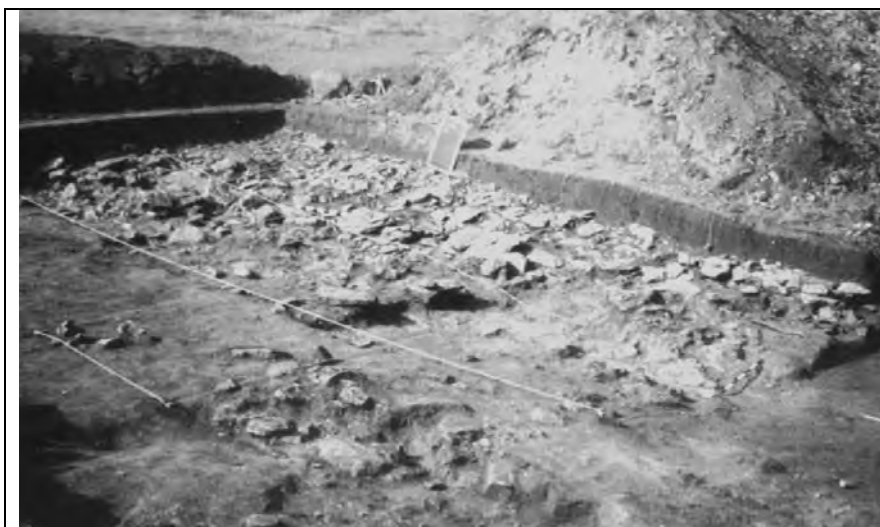
Fig. 19. House phase 3.1(L3.1) and room B (back), the doorstep (center), room A and phase 3.2 (L3.2 right).

Stage 3.2 (L3.2, fig. 19). The complex has now two fireplaces (fireplace 2 and 3), which were used in different stages. In both phases the complex has the same perimeter but the fireplaces and household areas have a different arrangement. In the more recent stage **L3a**, the fireplace has a rectangular shape, with rounded corners. The long axe of the fireplace was North-South. The fireplace was located in the eastern room (room **B**). A household area with broken vessels was near the interior wall, in the same room. A partition wall (with only one row of stone at the base), located eastwards from those belonging to stage **L3.1** was discovered on 2/3 of the complex's width; the entrance was on the southern wall. A part of the north - western corner with the south wall contains stones. The north - western wall of both stages has 1-2 stone rows. The South wall has 2-3 rows of stones, because the southern part is a little bit lower (this part is built over the ditch and it is not as resistant as the northern part built directly over the border of the defensive ditch). The western corner was destroyed by *Stone quarry*. Only one part of the south - eastern corner is still undisturbed. In this stage the house has a maximum of evolution and period of usage. The cooking area is outside the house (there are no traces of fireplace inside).

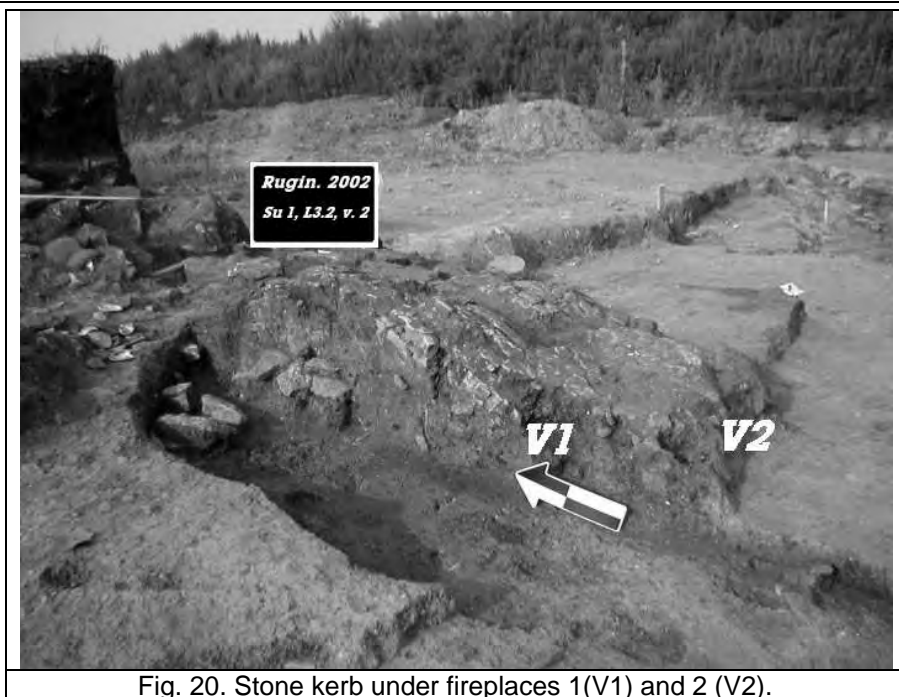
Fig. 20. Stone kerb under fireplaces 1(V1) and 2 (V2).

Fireplace 2, built over fireplace 1, was larger (1,30 - 1,40 m). In the new extended area 2 rows of stones have been used (fig. 20). This installation was disturbed in the same time with the base of the house and has undergone some local repairs. After we have cut the fireplace 1 and 2 we have found a stone kerb under fireplace 1. It is possible for fireplace 1 during its first phase to have had a stone kerb in the area close to the wall, covered with clay. This data show that the fireplace was carefully built and enlarged. This enlargement could have been necessary for heating a larger space, both rooms, or related to a cooler climate. We suppose that the family was bigger in this phase. On the fireplace we have found fragments from many pots (14-17), showing a more intensive cooking process. The repairs and the division of the space in two rooms are related to the heating system and economy (based on our ethno-archaeological experience and on historical analogies with the Roman houses from the second half of the III century – Cluj-*Piața Muzeului*).

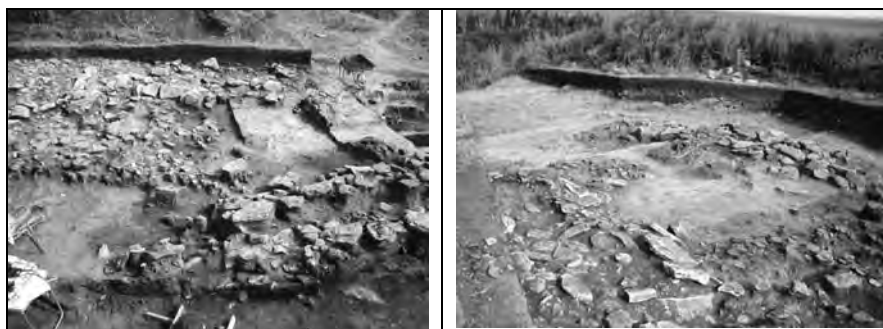
Fig. 21. House phase 3.2 and 3.3 (L3.2 and 3.3) ▲ view from NE and SV
▲ foundation stones glided in the interior.

If we look at **L 3.2** from South to North (fig. 21-22), we observe that in the southern area there is no stone foundation meaning that in this area was probably an entrance or a little porch. The base of a partition wall (made of stones) divided the house in two rooms. The east one (**A**) was closed. The walls have a stone base and here were the fireplaces and not too much pottery. The entrance of the West room (**B**) was in the South.

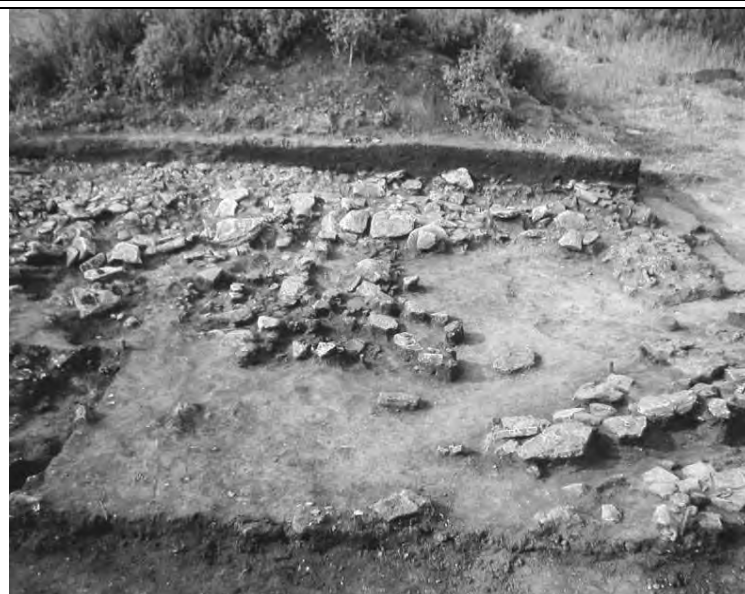
Fig. 22. House 3.2 (L3.2) View from N▲, plan ▼.

The house (photo and plan, fig. 22) has two reconstruction levels in the same plan; the same type of fireplace, differently oriented. Both levels have the same walls and the same western area was used for household activities. They also had the same entrance in the south, a kind of porch, maybe closed during wintertime. A fragment of a fireplace plate was found between the south wall and the fireplace.

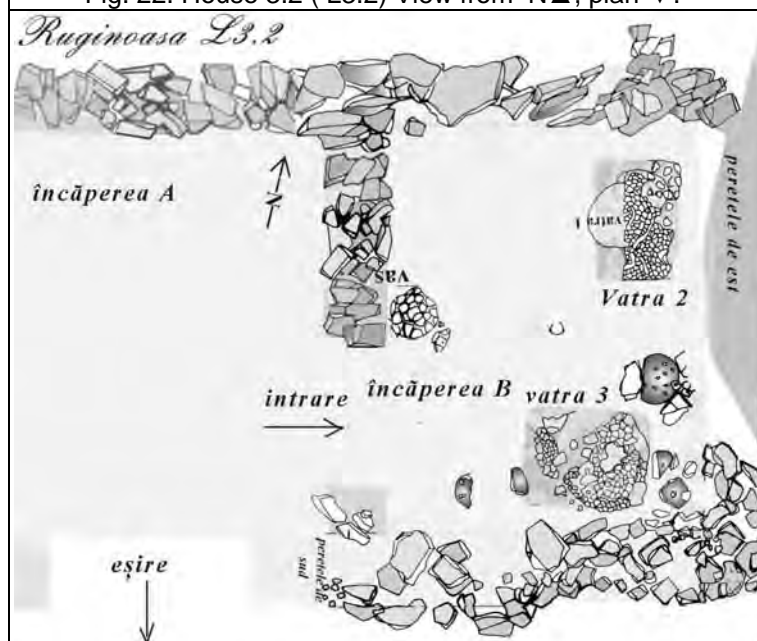
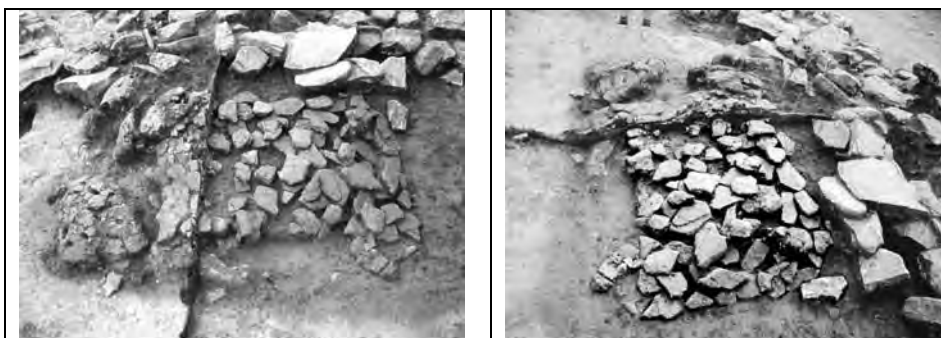
Fig. 23a, 23b. Fireplace 3 (V3).

Fireplace 3 (fig. 23) is better preserved. Beneath its level was a fireplace plate, contemporary with fireplace 2. Traces of a black stratum 6-8 cm thick go under fireplace 2, indicating a floor. The same system as in fireplace 1 and 2 was used for fireplace arrangement.

Some parts of the fireplace were callous (fig. 22-23). In both stages the part close to the wall has been upraised (fig. 23b).

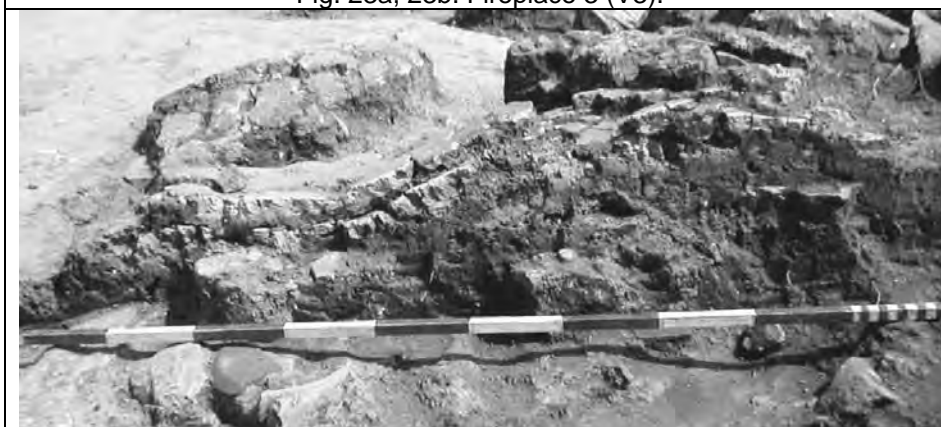
Fig. 23c. Profile through fireplace 3.

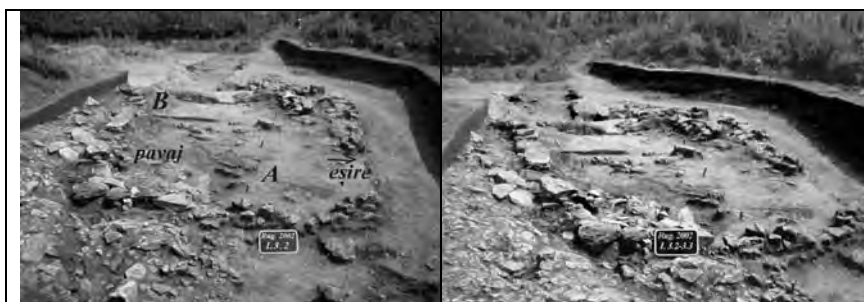
Fig. 25. House phases 3.2b-3.3 (L 3.2b-3.3) view from W.

Stage 3.3. (L 3.3). There are not many information regarding this stage. A partition wooden wall, built over a stone base (fig. 25) was dividing the house. Part of room **B** was paved with stones (the north-western corner, fig. 25). On this pavement we have discovered broken pots. On the south side of the wall, some stones have been moved and placed a little bit higher, because of the subsidence process.

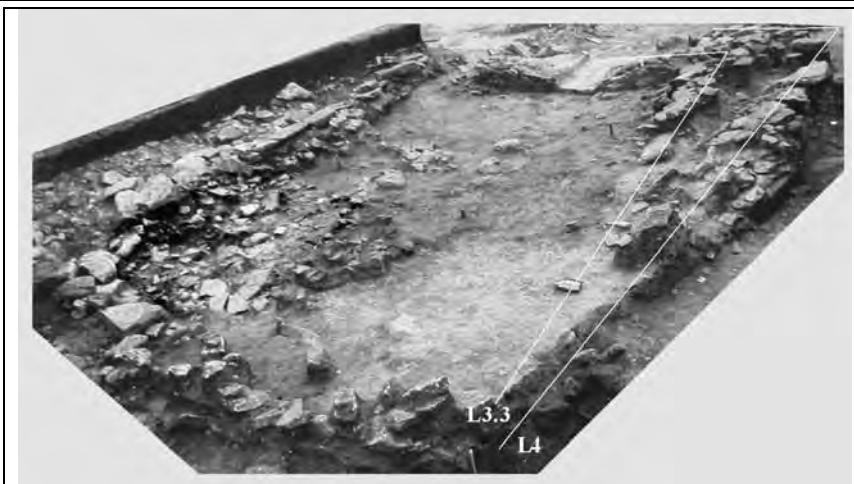
Fig. 27. House phase 3.3 (L 3.3) and house 4 (L 4), the southern wall.

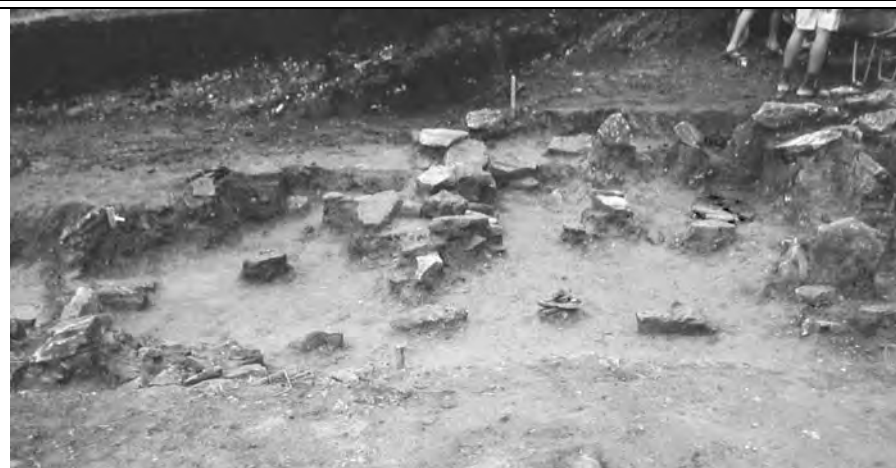
Fig. 30. Pit house 5 (B 5) view from N

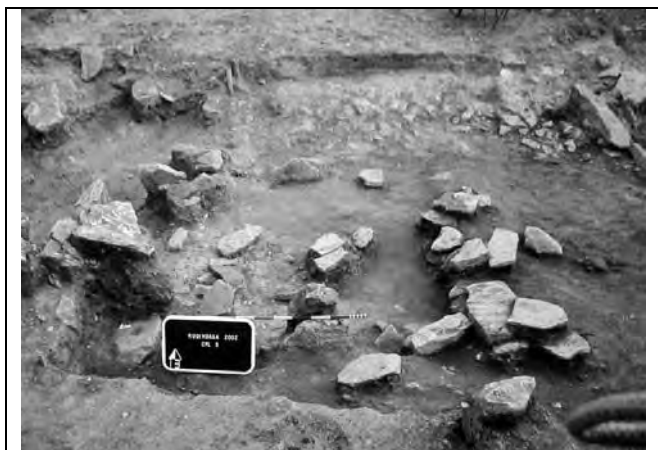
Fig. 33 Pit house 5 (B 5) ▲ its reconstruction ▼.

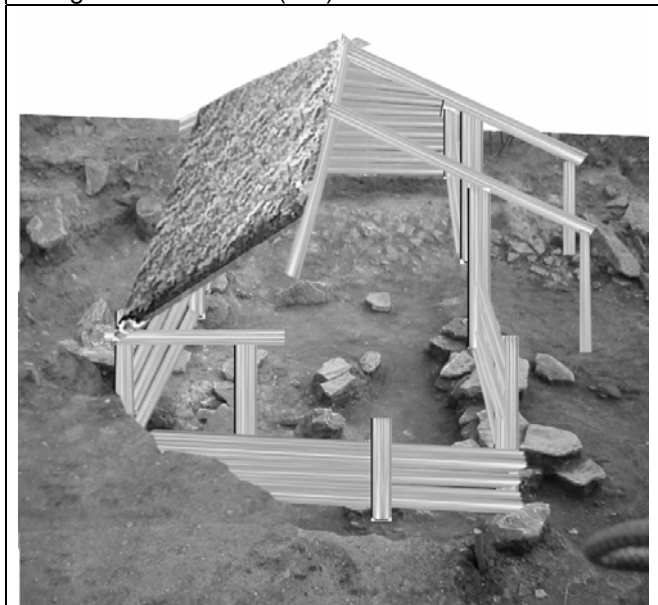
Reconstruction of complexes and installations

Houses. House 3 with 3 reparations stages, a subsidence process, the fireplaces area and their movement, the households activities areas are features that underline the life of a dynamic community. This community has changed its house building system, from the pit house type to the surface house type. For the reconstruction of the walls we have no or very scarce data. Our reconstruction is connected with the ethnographic field and with today realities from the countryside area. It seems that in the area we have made excavations the architecture is mainly based on wood (e.g. stone foundation, the absence of the adobe structures, few charcoal and ashes, yellow unburned clay). Even today houses made of wood have a long life, are very resistant and keep the heat. The wood used for building is without bark, processed or not, with some fix structure for the joining. We have tried to make some reconstructions for pit house 5 (B5) (fig. 33) or for the surface house 3 (L3) (fig. 34). Our reconstructions have been made using the computer and a special programmed.

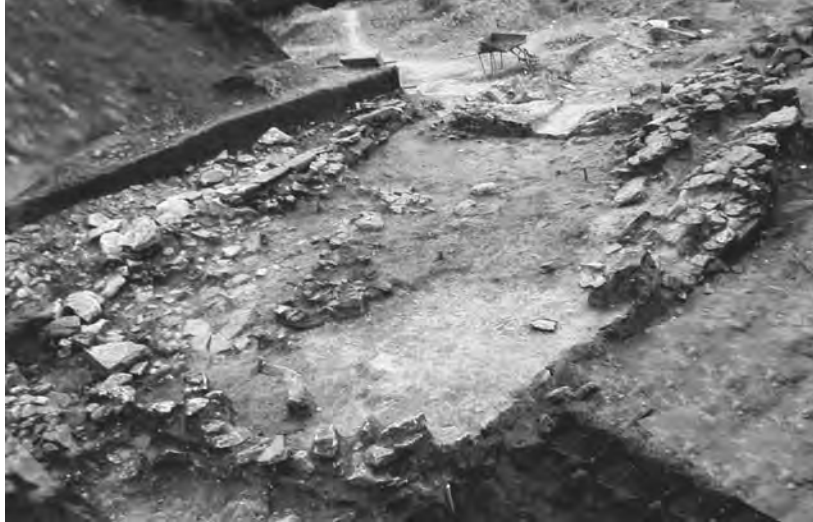
Fig. 34 House 3 (L3), plan and reconstruction.
